**Thorntown Creek Riparian Open Space
Assessment and Recommendation Report
For
City of Bordentown, New Jersey**

**Bordentown Open Space/
Thorton Creek
City of Bordentown, Burlington County, NJ**

Site Assessment and Recommendations

The following summarizes the findings and recommendations based on a site visit conducted on June 17, 2005 by Delaware Riverkeeper Network staff.

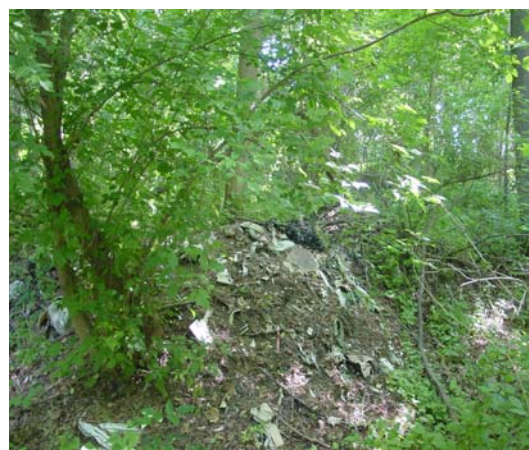
The upper reaches of the assessment area (from Rt. 206 to the railroad) have been disturbed over a long period of time. Above Elizabeth Street, dumping of fill material (see adjacent photo) and stormwater diversions have degraded the ecosystem on this municipal parcel. The "City Pond" dam built during the 1930's (formerly located just upstream of Elizabeth Street) was actively used for recreation until its breach in 1971 as a result of hurricane rains and jammed debris in the sluiceway. In addition, an area actively used as a BMX bike course maintains significant areas of bare soil. If the course remains intact, measures should be taken to limit any impacts to Thorton Creek. Below Elizabeth Street, an area near the railroad bridge that was also previously

Fill material dumped in upper reach.

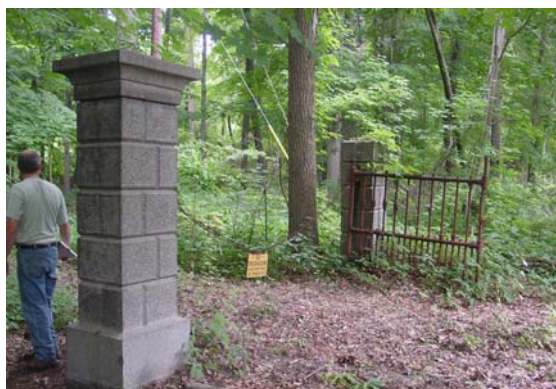
Former gate to Bonaparte Estate near Park St.

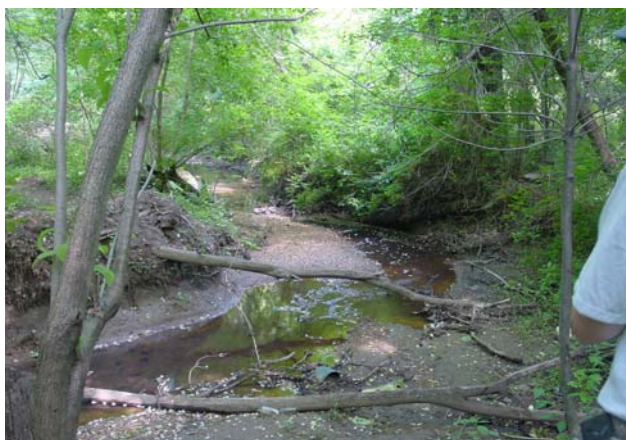
Creek near BMX bike course. View downstream.

Figure 3). In addition, after the dam was breached, the stream downcut through the highly erodible sediments that had accumulated within the impoundment. As a result, the stream has become disconnected from the historic floodplain and became confined to an entrenched (deeper) channel with a re-established a new floodplain. In the entrenched channel however, because the entrenched condition confines the stream during higher flows, this new floodplain will not have the same energy dissipating functions of a natural floodplain.

Severe erosion has caused much of the stream to downcut below the root protection zone of many trees/shrubs growing along the banks. This lack of root protection has lead to steep bank angles (which

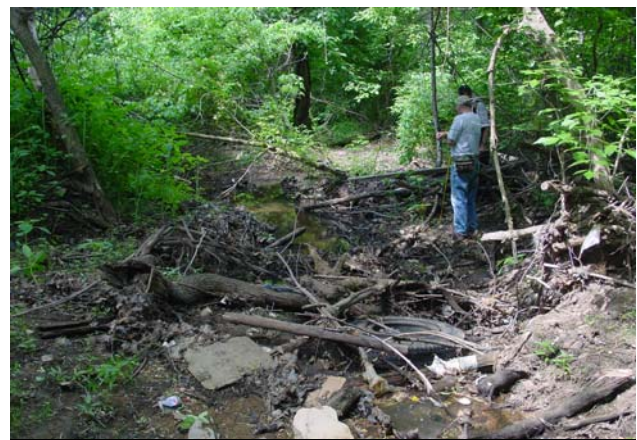
Debris jam along Thorton Creek.

Another stability impact in this section includes the abundance of large woody debris. While large woody debris is considered beneficial to aquatic habitat, an excessive amount (a result of upstream erosion) of woody material has created several debris jams throughout this section. These jams have created erosion in several areas. A larger problem is the potential for braiding of the stream channel (forming more than one active channel). This appears to have happened in at least one area as a result of a previous debris jam.

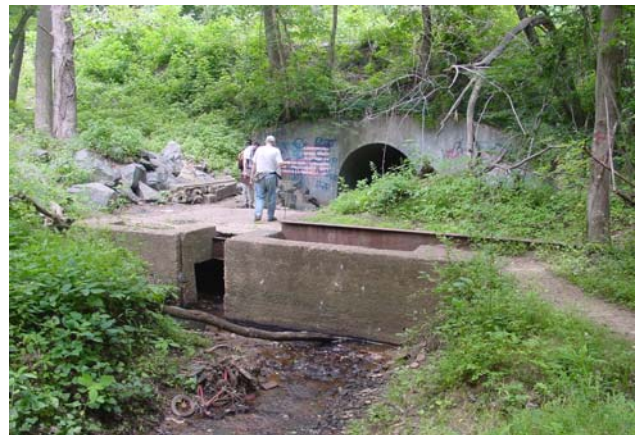
Below the areas of debris jams, the remains of a large concrete dam near the railroad (the dam also reportedly doubled as a stream crossing for a neighboring military academy which operated until 1970 (dam visible on historic topo map found in Figure 3). Although the dam no longer holds an impoundment, the structure itself is still intact and causing local erosion around the structure.

Dam remains upstream of railroad bridge.

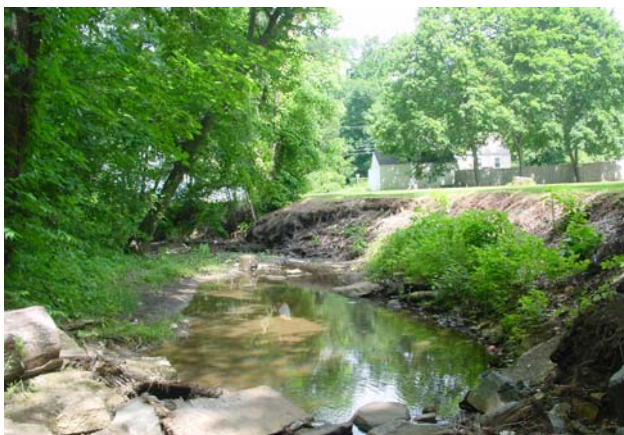
Below the railroad bridge, riparian land use changes dramatically. This section (Railroad to Park St.) is the only section with private residential property along the stream. Unfortunate, this land use has led to the nearly complete loss of a riparian buffer throughout this reach except for a small wooded parcel. The effects of no riparian buffer are clearly evident in this portion of Thorton Creek. As reflected in the assessment scoring, severe bank erosion is evident and active. Without stabilization provided by trees and shrubs, many areas have scoured out leaving steep eroded banks (See picture below).

Bank erosion along residential properties.

#2 Bank stabilization. Severely eroded and unstable areas should be stabilized using ecologically sensitive approaches such as bioengineering or natural channel design techniques. Priority areas include severely eroded banks along private residential property and entrenched areas within former impoundments.

#4 Encourage changing private residence riparian practices. The creation of no-mow areas along the banks and re-establishing a vegetated buffer with attractive native species would improve the stability of banks along eroded residential properties. Mowing or placement of fill, lawn clippings, or horticultural debris on the banks should be avoided as this inhibits the establishment of plants that could help stabilize the banks. In some areas simply not mowing will allow vegetation to reestablish naturally, in other areas invasive species may be controlled prior to supplemental planting of native species.
