**Thorntown Creek Riparian Open Space
Assessment and Recommendation Report
For
City of Bordentown, New Jersey**

**Bordentown Open Space/
Thorton Creek
City of Bordentown, Burlington County, NJ**

Site Assessment and Recommendations

The following summarizes the findings and recommendations based on a site visit conducted on June 17, 2005 by Delaware Riverkeeper Network staff.

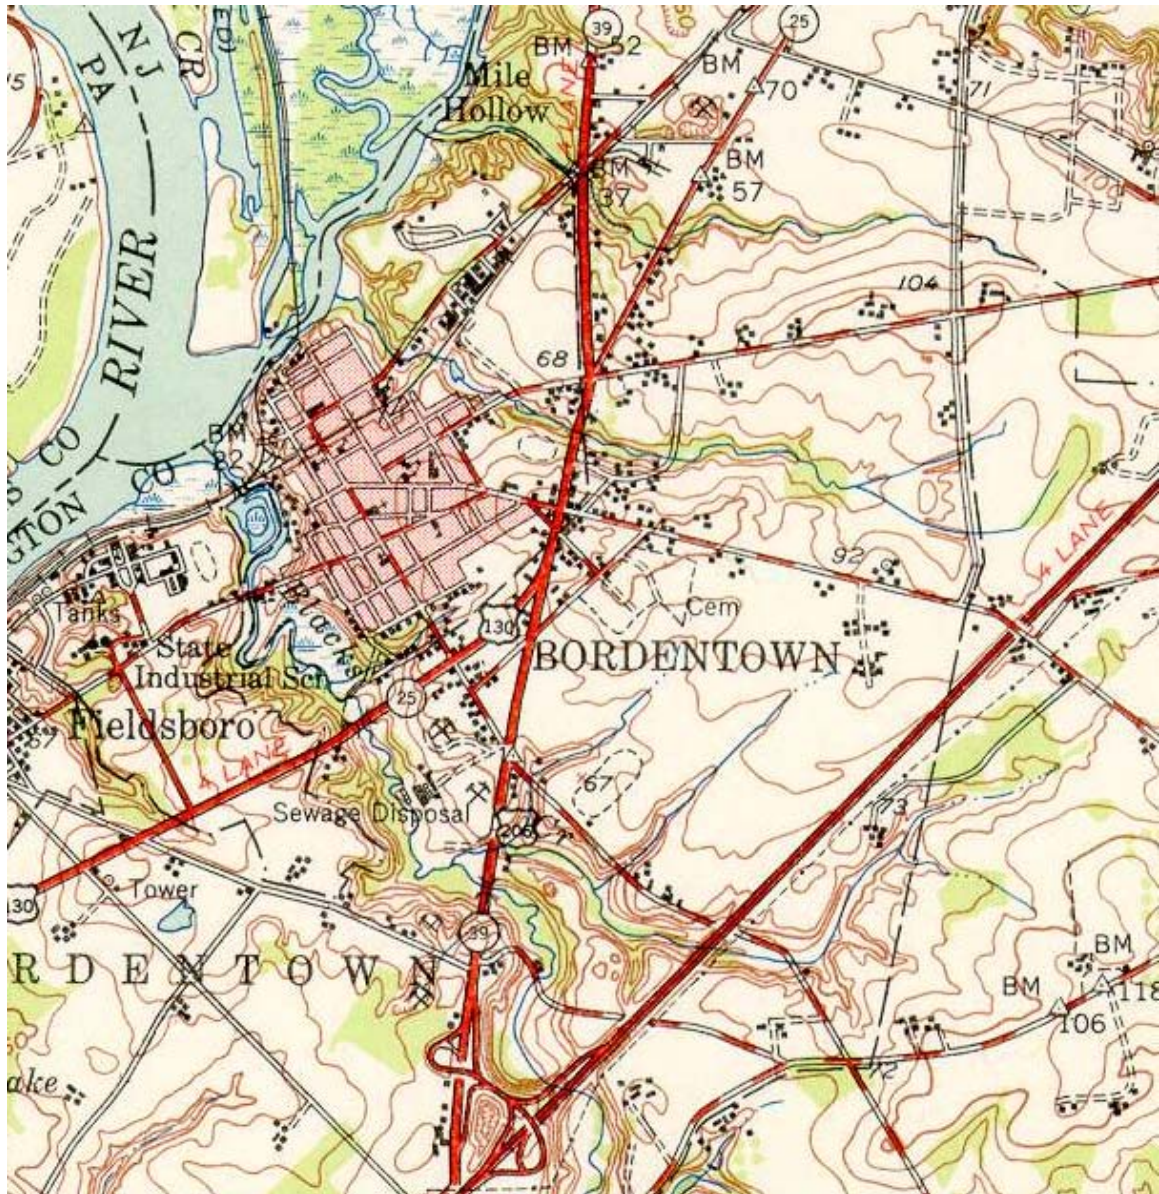
FIGURE 3.
1956 USGS Topographic Map – Thorntown Creek Watershed

impounded for aesthetic and recreational purposes (visible in topo maps from 1956, see Figure 3). The "BMI Pond" (Bordentown Military Institute) was also built in 1930's, and subsequently retrofitted. It survived the hurricane in 1971, however BMI closed shortly thereafter-in early 1970's. The impoundment disappeared sometime shortly after as dam maintenance was neglected.

Below the areas of debris jams, the remains of a large concrete dam near the railroad (the dam also reportedly doubled as a stream crossing for a neighboring military academy which operated until 1970 (dam visible on historic topo map found in Figure 3). Although the dam no longer holds an impoundment, the structure itself is still intact and causing local erosion around the structure.
